# Flood Grouting for Infiltration Reduction on Private Side Sewers

# FLOOD GROUTING FOR INFILTRATION REDUCTION ON PRIVATE SIDE SEWERS

Martha Burke  
Seattle Public Utilities

M. Steven Merrill  
Robert W. Jacobsen  
H. Justin Twenter  
Brown and Caldwell

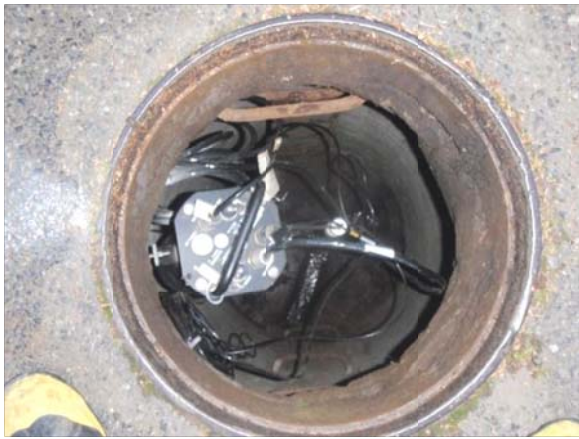
Figure 2-7. Flow Meter Data Logger.

Flow meters were installed throughout the Broadview sewer basin to assist in building a calibrated hydraulic model. Additional flow meters were added to this network to assist in developing a more focused model for the pilot project area. The flow meters recorded observations of depth and velocity in the sewer pipes every five minutes. An independent flow metering company was responsible for the operation of the flow meters and data processing. A typical flow meter installation is shown in Figures 2-7 and 2-8.

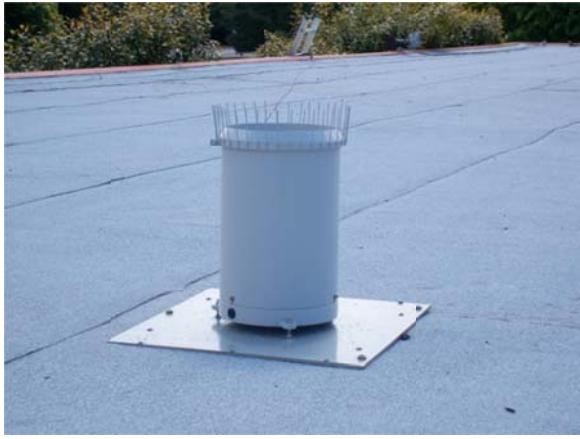
Figure 2-11. Rain Gauge 07 Tipping Bucket.

SPU currently maintains a network of rain gauges throughout the city. Rain gauges 01 and 07 were used for this project. The locations of the rain gauges are shown in Figure 2-10. Rain gauges are tipping bucket-style. The rainfall information used for this project was at logged at one-minute intervals. Typical installations of the rain gauges are shown in Figures 2-11 and 2-12.

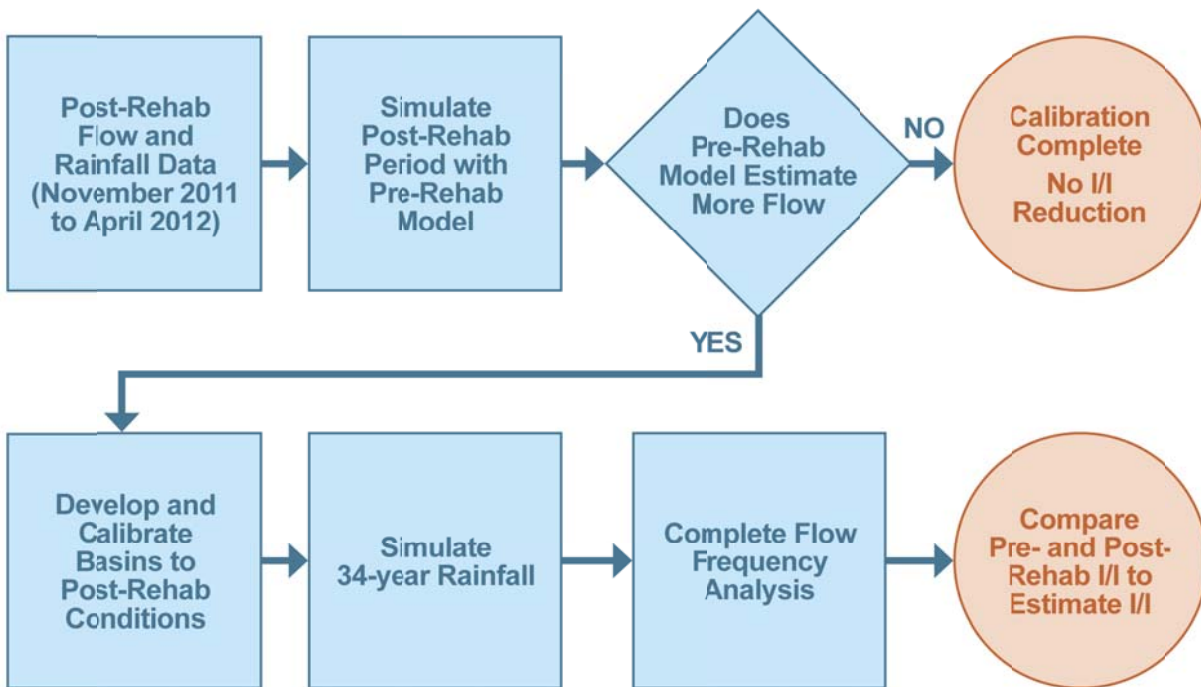
Figure 2-13. Modeling Approach for Estimating I/I Reduction.

The method utilizes long-term (continuous) simulations of two models – one calibrated to before and one calibrated to after rehabilitation conditions – to develop I/I flow occurrence (Log Pearson Type III [LP3]) frequency distributions. Comparison of the frequency distributions, for specific return intervals, is used to measure I/I removal effectiveness. More details regarding this analysis method are found in the WERF report (Merrill et al., 2003).

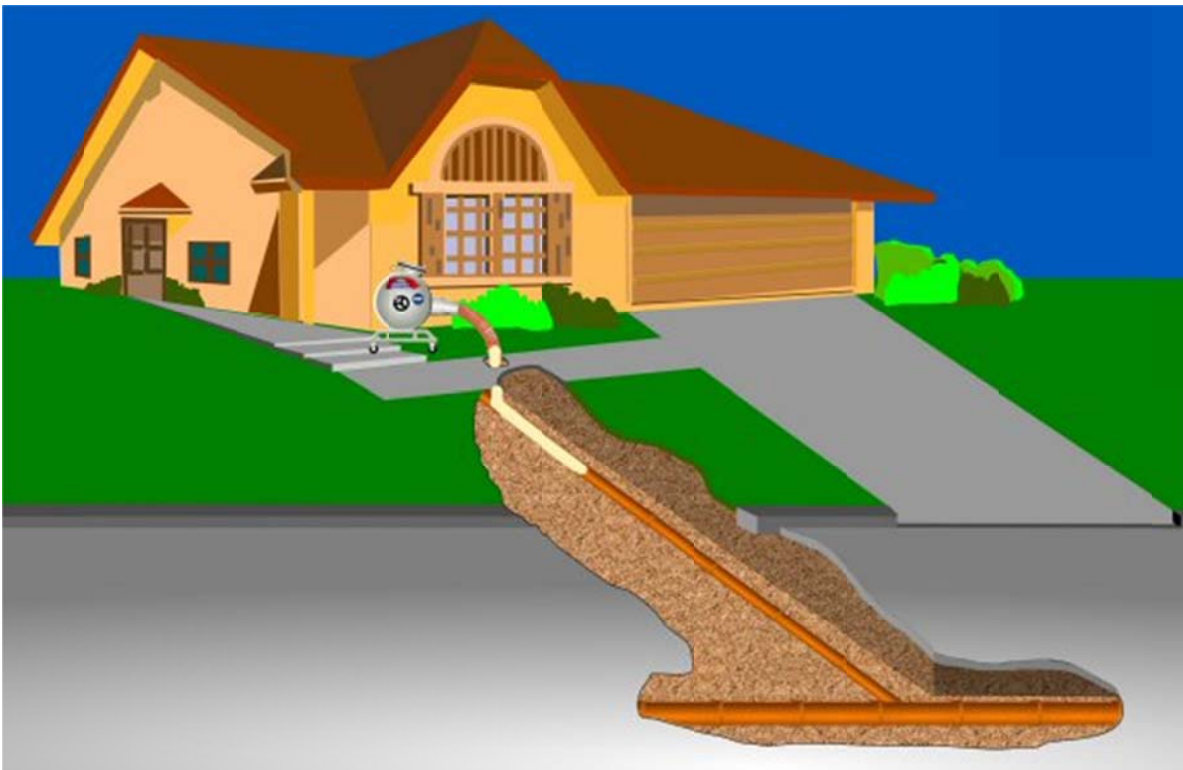
Figure 3-3. CIPP Lining.  
(Perma-Liner, 2012)

A disadvantage of lining pipes is that the liner follows the alignment of the host pipe, meaning that a sag in the host pipe will remain in the lined pipe. If there are severe offset joints or many fittings, lining cannot be completed. It is possible for roots to grow into the annular space between the liner and the host pipe that could damage the liner. If hydrophilic end seals are not used, groundwater can migrate along the annular space and re-enter the sewer system.

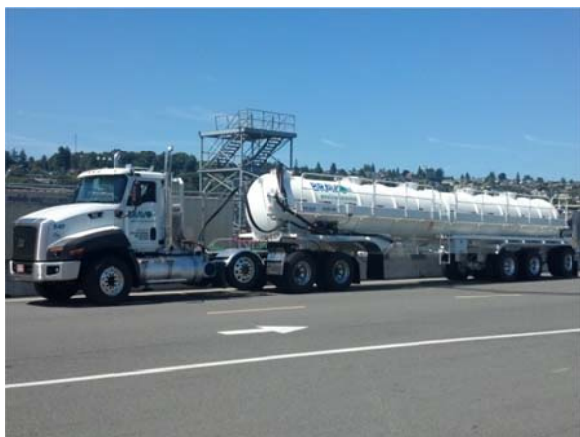
Figure 5-1. S1 Tanker Delivery.

Sanipor requires a license agreement to be able to use its product. SPU and Brown and Caldwell introduced Bravo and Sanipor to each other for the two parties to negotiate and develop a temporary project-specific license agreement. The cost for this license was passed on to SPU. Sanipor ordered the chemicals from EKA Chemicals, Inc. The S1 (manufactured in Moses Lake, Washington, Spokane, Washington, and Portland, Oregon) came in large tanker trucks (Figure 5-1) and the S2 (manufactured in Green Bay, Wisconsin) came in 270-gallon tote bins (Figure 5-2).

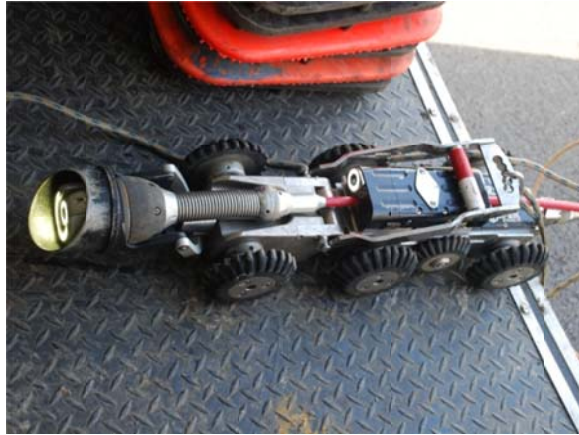
Figure 5-4. Side Sewer Inspection Camera.

Several of the houses could not be inspected from the mainline for several reasons. At these houses, push cameras (Figure 5-4) were used through existing inside cleanouts or by removing toilets and inserting the camera through that opening. The inspection of the side sewers revealed that the geographic information system (GIS) mapping of the side sewers in this area was incorrect at several locations. Project-specific mapping was updated to reflect the correct location of the side sewers and all cleanouts were surveyed to record their location. The side sewers were found to be in a similar condition as the mainlines.

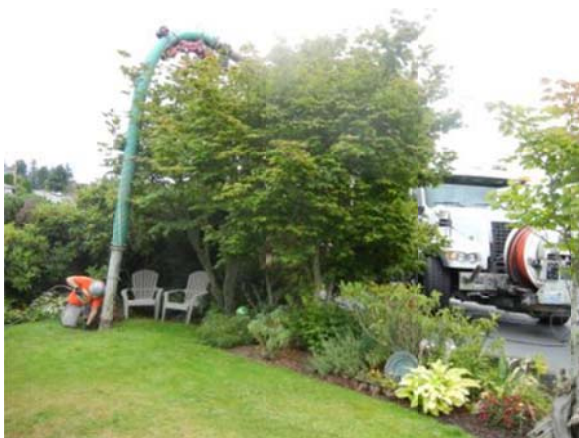
Figure 5-5. Excavating for Vac-A-Tee.

Following inspection, the cleanouts were installed at the locations identified by the internal inspection. In some instances, landscaping and homeowner approval modified the previously identified locations. Due to the multiple branches (as shown in Figure 5-3), landscaping, elevation differences, and homeowner approvals, approximately only 30% (about 3,000') of the total side sewer length could be sealed. The cleanouts were installed by the Vac-A-Tee method, as shown in Figures 5-5 and 5-6. This minimally invasive process utilizes vacuum excavation to expose the side sewer to determine where a new riser pipe can be attached.

Generally this operation went smoothly, except in a few places where the locations from the internal inspection were off by a few feet. In these circumstances the excavated hole ended up being larger than it otherwise would have been.

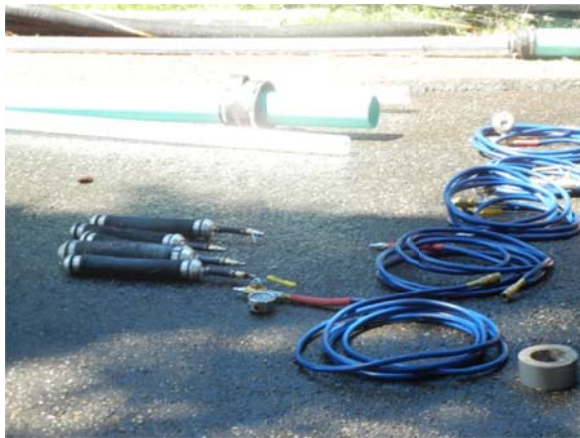
Figure 5-7. Side Sewer Plugs.

The flood grouting operations began on August 10, 2011, and were completed on October 5, 2011. Grouting operations were done under the onsite guidance and direction of Sanipor representatives. Prior to any sewer shutdowns, residents received notice four days and again one day before the operation that they could not use water during the grouting process, generally from 9 a.m. to 6 p.m. Copies of the advanced shutdown notices are included in Appendix D. The flood grouting process began with a pre-cleaning of the MHs, mainlines, and side sewers. Next, plugs were installed in upstream and downstream MHs in the mainline pipe and side sewers through the newly installed cleanouts. Logiball Push-Type plugs, Type A, were used to plug the side sewers through the cleanouts. The plugs were inserted on the house side of the cleanout, leaving the cleanout unobstructed to allow air to escape while the system is flooded. Figures 5-7 through 5-10 depict the process of plugging the side sewers.

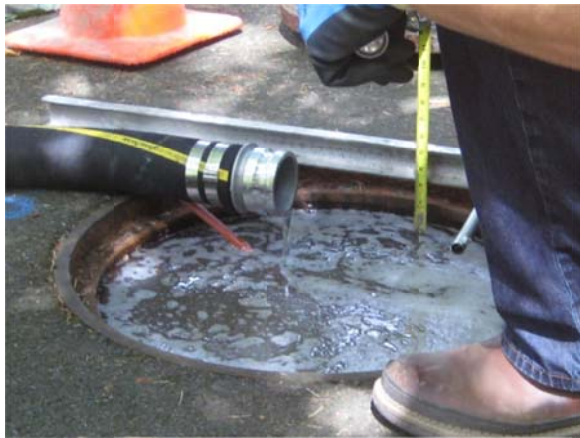
Figure 5-11. Filling and Measuring S1.

Once all the plugs were installed, S1 was discharged into the upstream MH and allowed to fill the entire system until the liquid level reached the upstream MH rim. The liquid level was measured every five minutes to monitor its exfiltration rate. If the liquid dropped excessively, the level was topped off to maintain the maximum possible hydrostatic pressure on the system. After a period of 30-45 minutes, S1 was extracted out of the MH back into the vector truck. The system was then rinsed to remove as much S1 from the inside of the pipes as possible to keep S1 and S2 from reacting inside the pipe, potentially causing a blockage. All of the plugs were reinserted and the process was repeated with S2. During the grouting process a contractor constantly monitors the pressures of the plugs to immediately identify any issues should they arise. The filling and measuring process of the two chemicals are shown in Figures 5-11 and 5-12.

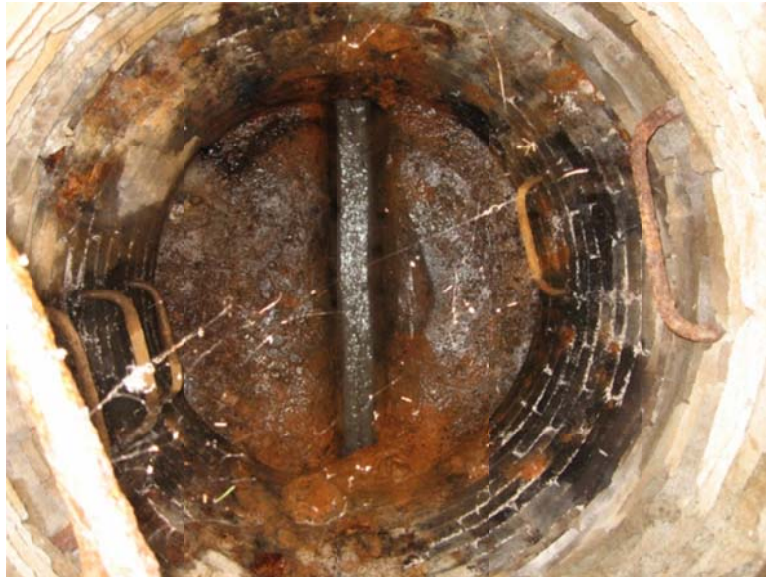
Figure 5-13. Leaky Concrete Block Maintenance Hole.

In several instances, the first application of S2 did not achieve the desired exfiltration rate. In these cases the whole process was repeated until the segment achieved the desired sealing goals. The sealing goal, provided by Sanipor based on European acceptance of new concrete pipelines, was set at an allowed exfiltration rate of 0.74 gallons per 100 square feet of wet inner surface in 30 minutes. The exfiltration depths were recorded and are stored in graphs as shown in Figure 5-14 and Appendix E. A typical setup is shown in Figure 5-14, where the upstream MH was treated separately from the mainline to minimize chemical loss and to assist in achieving the greatest sealing potential. The majority of the MHs were made from concrete blocks and were very leaky, as shown in Figure 5-13.

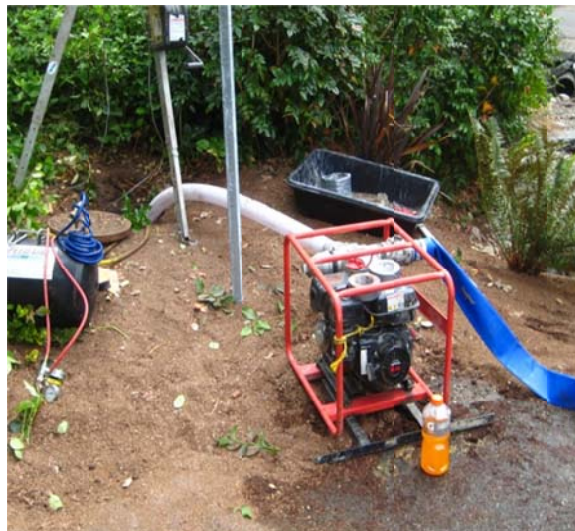
Figure 5-15. Bypass Pumping Setup.

Only four to five segments required actual bypass pumping during the grouting operations. Typically the upstream pipe could store any received flows or a flow-through plug could be used to transport sewage through an MH without contaminating the grout. When bypass pumping was required, a small trash pump was used to pump accumulated sewage via a 3”-diameter discharge hose running along the street to the next downstream MH (Figure 5-15).

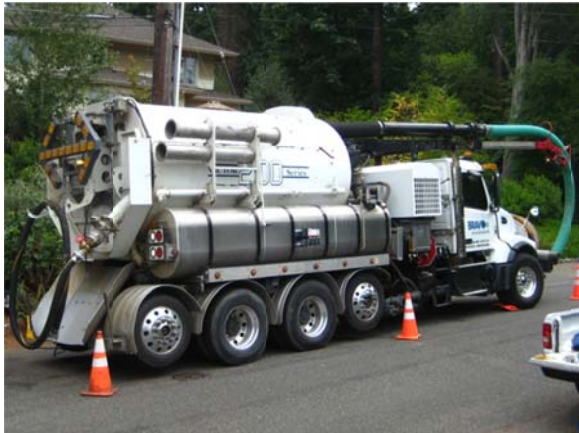
Figure 5-16. S1 Truck.

Equipment	Details
S1 truck (Figure 5-16)	2008 Vactor 2115 centrifugal compressor combination sewer cleaner (fan unit) 15-cubic-yard debris barrel 2,500 gallons of liquid storage (S1) 5-axle 68,500-pound gross vehicle weight (GVW) 0 to 8,000 cubic feet per minute (cfm): operating range 2,500 to 4,500 cfm
S2 truck (Figure 5-17)	2007 Volvo VHD swap loader 4,200-gallon Predator vacuum body (roll off) 550 cfm Fruitland rotary vane vacuum pump 7-axle 78,500-pound GVW (single), 105,500-pound GVW (tandem)
Sewer plugs	Ten 4" Logiball pneumatic side sewer plugs Ten 6" Logiball pneumatic side sewer plugs Four 6" to 12" pneumatic blocking plugs Four 6" to 12" pneumatic flow-through (3") plugs Four 8" to 12" pneumatic flow-through (4") plugs

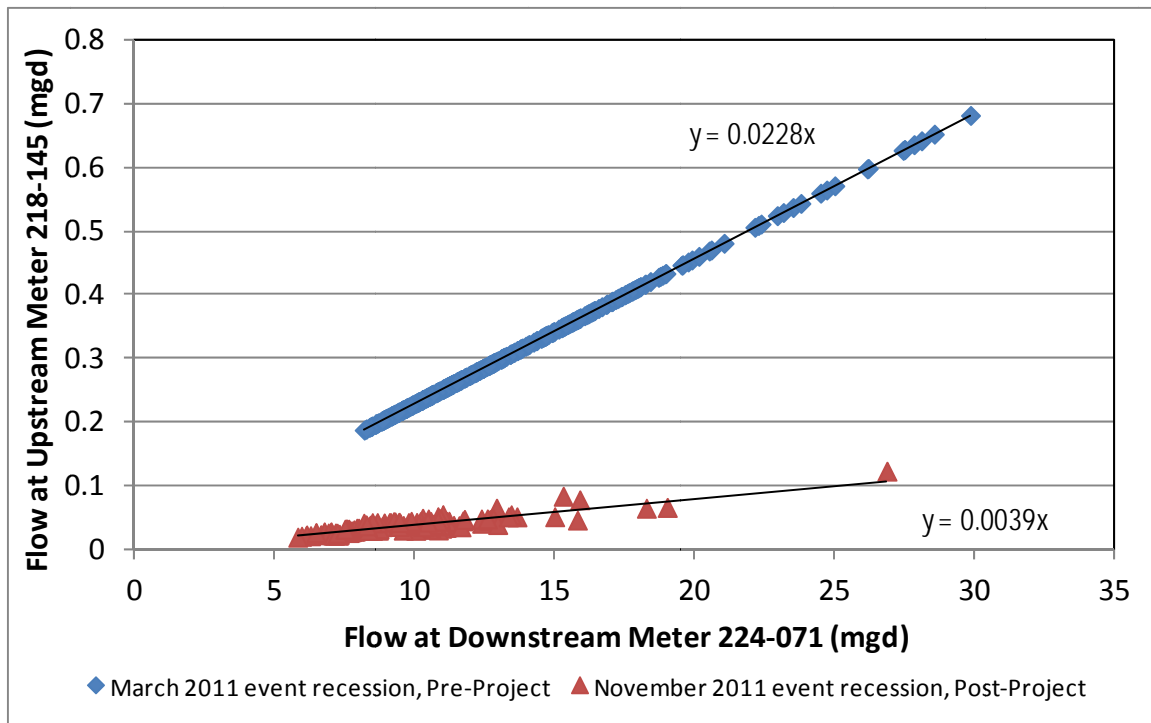
Figure 6-3. Scatter Plots of Flow at Meter 218-145 Against 224-071 Flow for Recessions of March 2011 and November 2011 Events. The Relationship is Obviously Changed.

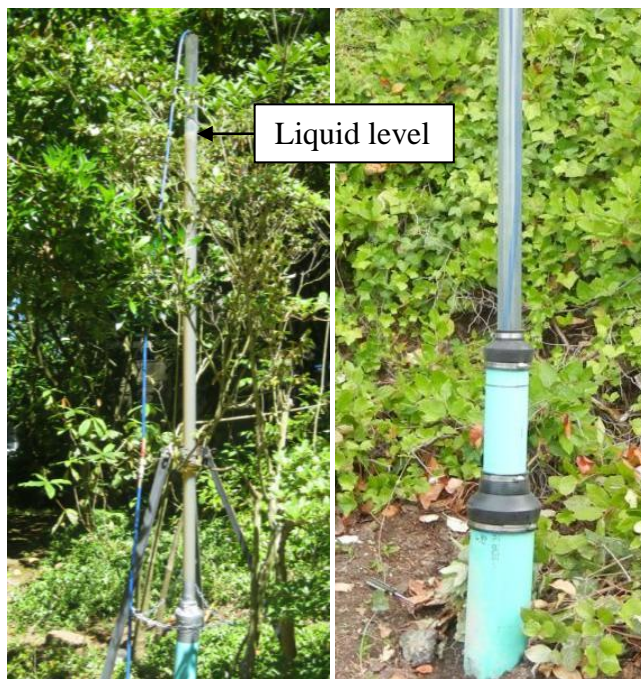
Figure 6-13. Riser Pipes.

As with any new technology, challenges and unanticipated conditions were encountered. First and foremost was the topography of the project site. The hilly site has considerable elevation differences between upstream and downstream MHs and the high and low sides of the street. The worst-case MH-to-MH reach had a 30-foot difference in rim elevations, and that occurred over a horizontal distance of 250'. To maximize the application of the grout, riser pipes were installed on low-side cleanouts to help manipulate the hydraulic grade, as shown in Figure 6-13.

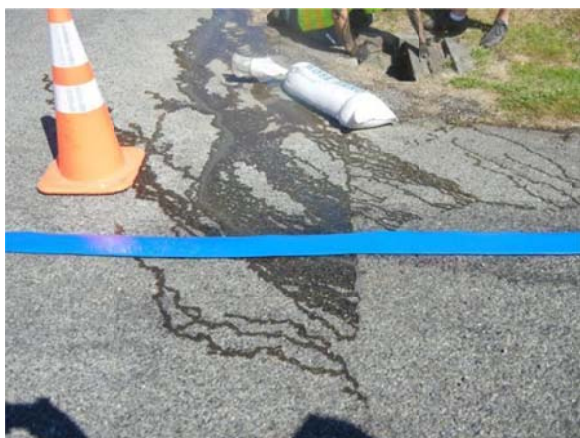
Figure 6-14. S1 Leaking Through Pavement.

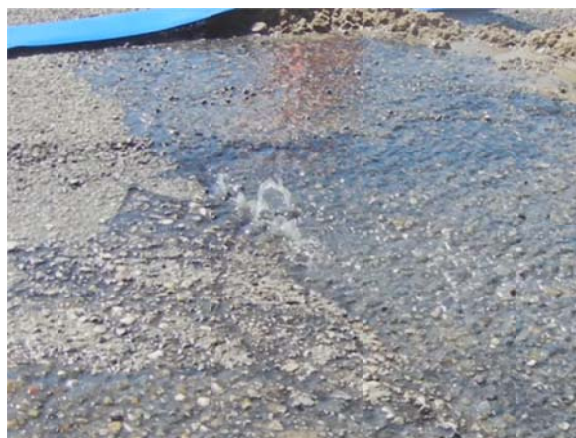
Figure 6-15. S1 Projecting Through Pavement.
