## Broadview Infiltration Reduction Pilot Project

September 13, 2011

## The Sanipor® Process Silicate based Flood-and-Grout

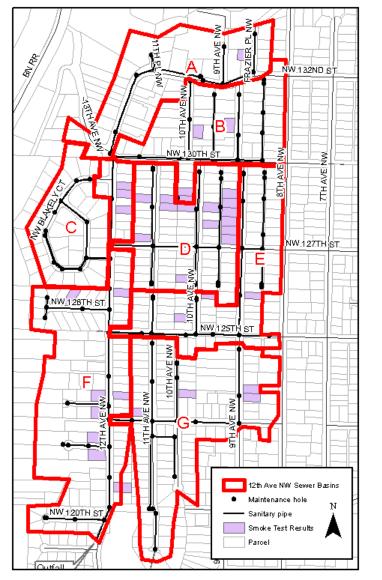
Most "upstream" basin ("A" and "B")

- Limited known inflow sources
- Large enough to accurately measure flow
- Good metering location
- Business case evaluation

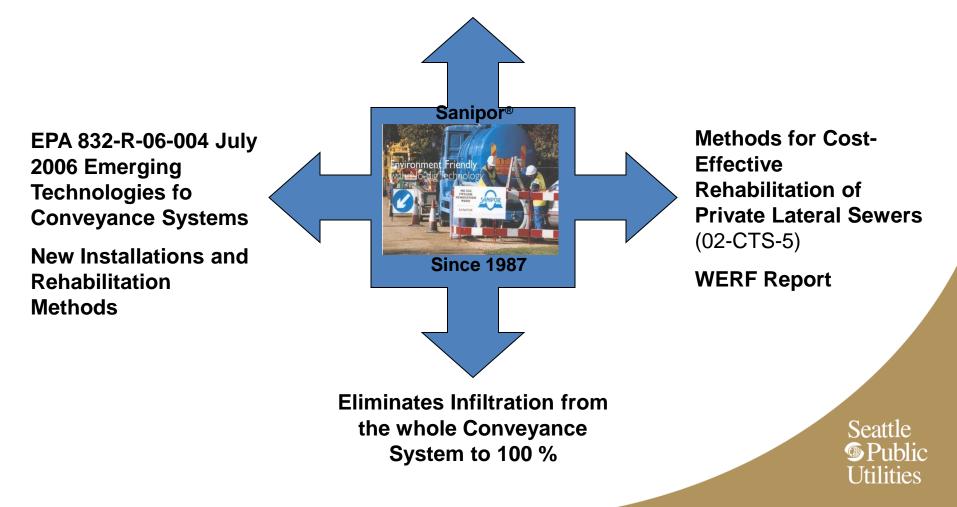
Seals all parts of one gravity fed pipe section between two manholes in a two step operation

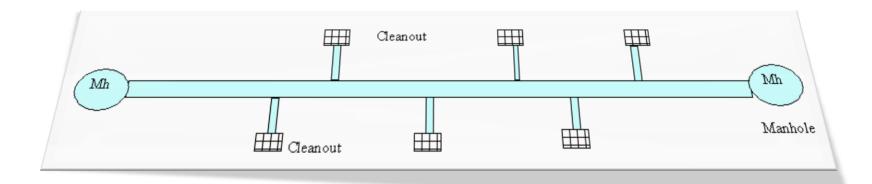
### Sanipor's view on the Sewer System

### - one work unit -

MODEL-SECTION	Average Sizes of a MH to MH Section				
Mainline:	8 inch, 280-300 feet long				
Manholes (2)	48 inch, 6 feet deep				
Laterals (6)	6 inch, 25-30 feet long each (162 feet)				
	total: 454-474 feet of all pipes

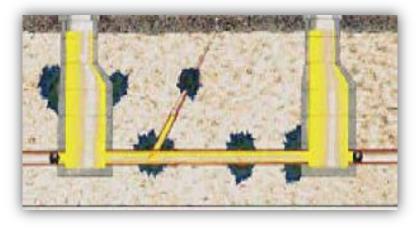
### Sanipor<sup>®</sup> - The Silicate Based System for Sealing Sewers

The section is immediately refilled with solution S2 which reacts with S1 in the ground. This starts to form a concrete-like matrix, binding the soil particles and sealing all leaks with solidified ground around the defects.

When the reaction is complete and the water-tightness established, Solution S2 is pumped out. After flushing , the sewer is returned to service. The pipe's structure protected from further deterioration.

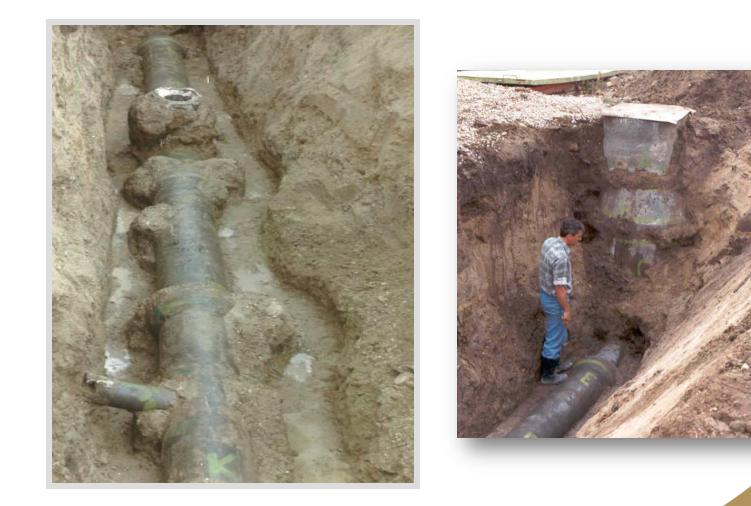
# The sandstone like, watertight layer around the sewer system - demonstration trench

Excavated trench after sealing the pipe

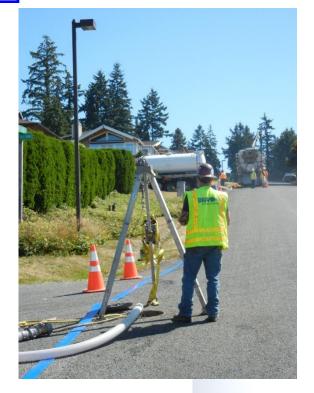
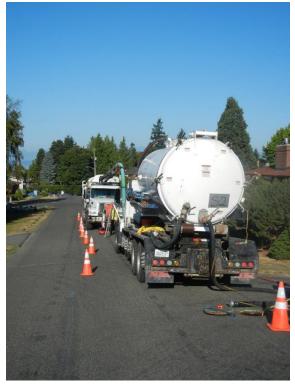
## Typical pictures of a Sanipor job site

Downstream Manhole

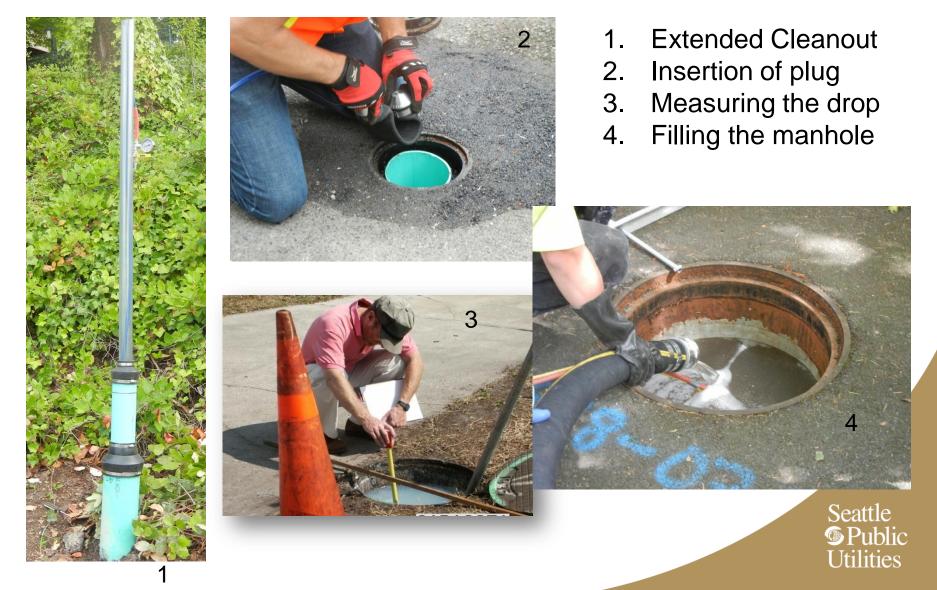
### Measuring of the drop of S-2 in the manhole

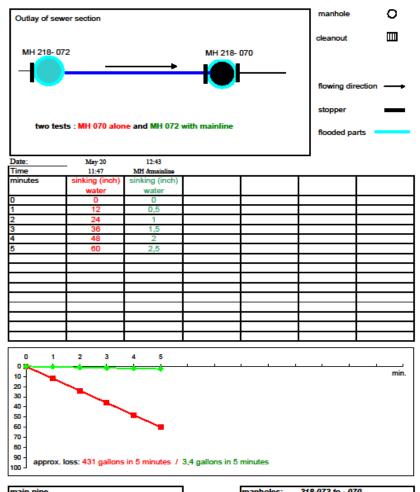
### Sanipor - Hydrotest protocol

### main pipe EN 1610 Øinch length(feet) vol.gall allowances 151 394 1,4 gal/ 30 min 8 3,4gal/30 min

mannoles:	218-072 10 - 070						
Øinch	dept (feet)	volume gallons					
48	15	1409,00					
48	11,8	1108,00

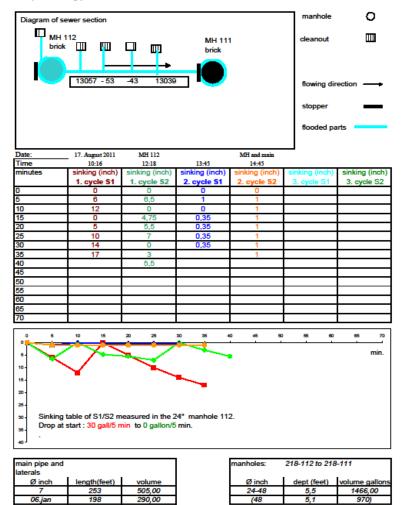
### Sanipor - Sealing protocol

Location: Seattle Date: 17 August 2011 Supervisor: Csilla Pall, Ferenc Pall Bravo Envrionmental Inc. Contractor:

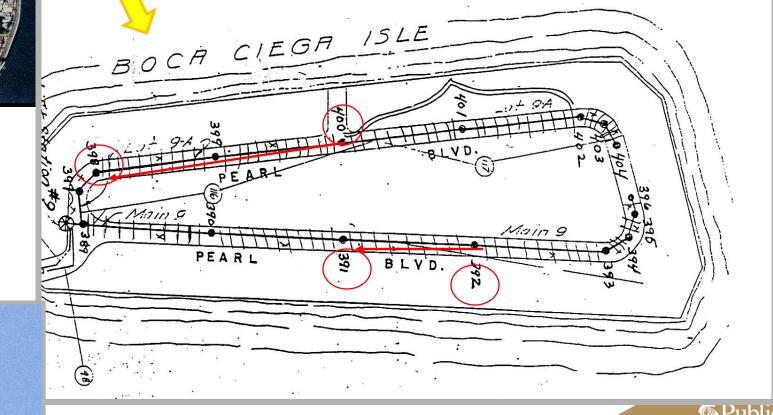
### City of St. Petersburg Beach, FL Sanipor<sup>®</sup> Infiltration Removal in 1992 CCTV Inspection in 2002

16 brick mhs, 15 mains - DN 6,8 ", 3286 ft, vcp, 98 laterals orangenburg, 1 lift station, salt water infiltration, 7-8 pumping hours p.d.

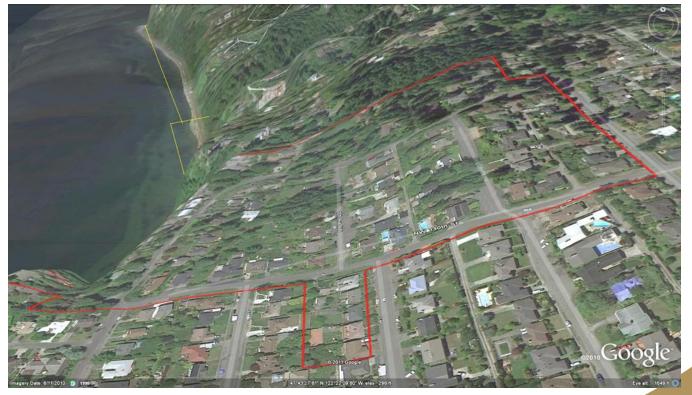
## □ Topography

30 ft difference between upstream and downstream MH
